Out-of-plane response of masonry walls strengthened using textile-mortar system

The out-of-plane response of masonry walls strengthened with textile-reinforced mortar (TRM) is experimentally investigated in this work. Medium-scale three-point bending tests were carried out on 18 specimens comprising a set of 9 single-wythe and 9 double-wythe brick masonry walls. Key investigated parameters involved the textile reinforcement ratio, the textile material, the coating of the textile reinforcement with epoxy resin, and the wall thickness. Experimental results suggest that TRM significantly increase the load bearing capacity of masonry walls. The amount of reinforcement utilised affects both the strength and deformation characteristics of the corresponding specimens, while it may alter the failure mode. Resin coating on the textile is found to be beneficial for the performance of the TRM overlays.

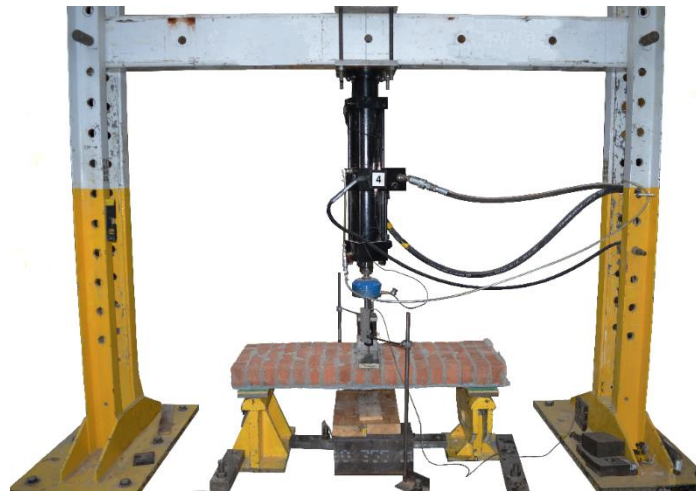
Fig. 1 Experimental setup; (a) plan view and elevation (all dimensions in mm) (b) actual setup

(a)

(b)

The wall specimens with their corresponding parameters are shown in Table 1. The strengthening configuration is shown in Fig. 1a while the actual test setup is shown in Fig. 1b. The notation considered for the strengthened specimens is W_XN, where W denotes the single or double-wythe walls (S for single and D for double-wythe wall), X denotes the type of the textile (C for carbon, G for glass and B for coated basalt) and N denotes the number of layers (1, 3 and 7). The suffix Co denotes textiles coating with epoxy resin.

A three-point-bending loading configuration was adopted for the out-of-plane tests of the masonry walls, resulting in an effective span of 1125 mm, as shown in Fig. 1a. The supports were spaced 107.5 mm from the ends of the masonry wall. The test setup consisted of a stiff steel reaction frame fastened with a vertically positioned actuator as shown in Fig. 1b. A 100 kN capacity servo-hydraulic actuator, used for the load application at a displacement rate equal to 0.017 mm/s (i.e., 1mm/ min). Two potentiometers were used to measure the out-of-plane displacement at mid-span. The transducers were placed at a distance of 50 mm from each side of the wall, as shown in Fig. 1a. Data was collected at a frequency of 4 Hz, synchronised and recorded using a fully-computerized data acquisition system.

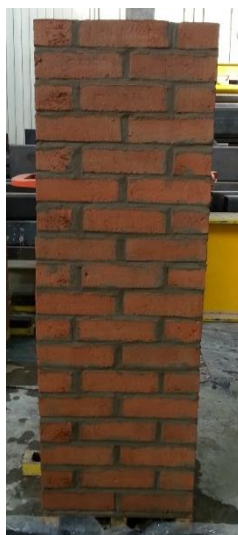
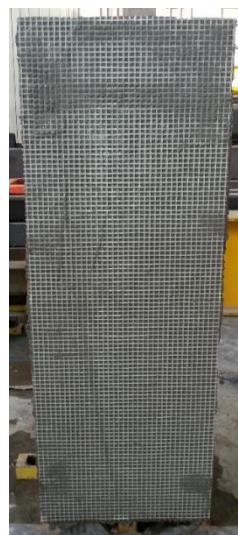
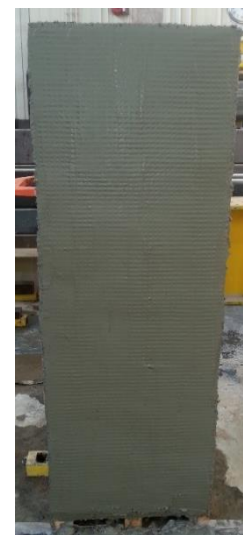
Fig. 3 (a) Dampening of the wall (b) application of glass textile layer into the mortar (c) application of the final layer of mortar

(a)

(b)

(c)

1. Air pressure was used to remove dust from the masonry wall surfaces to be strengthened with the TRM composite.
2. The wall was slightly dampened and a first layer of mortar was applied at the whole surface of the wall (Fig. 3a).
3. The first textile layer was applied and impregnated into the previously applied mortar layer using hand pressure (Fig. 3b). It is noted that in all specimens, the textile covered the entire brick wall surface to be subjected in tension.
4. Application of a final layer of mortar to completely cover the textile. For multiple strengthening layers the procedure of alternate textile and mortar layer was repeated. The procedure was completed while the mortar was fresh to achieve optimum adhesion of the TRM layers. The final strengthened configuration is presented in Fig. 3c.

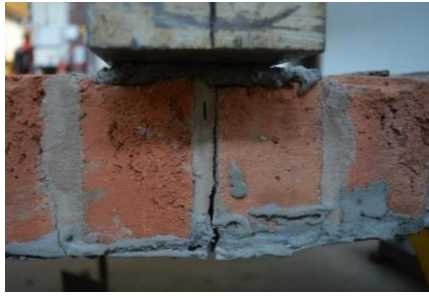
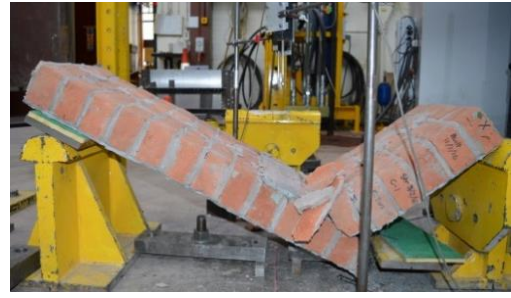
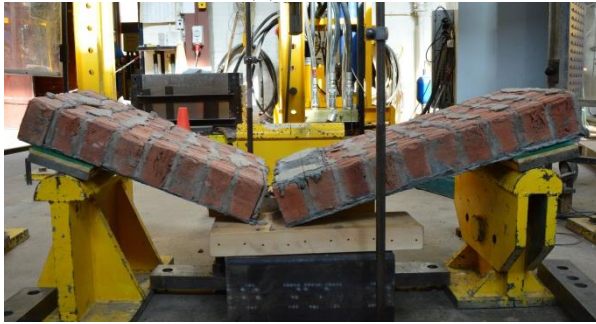
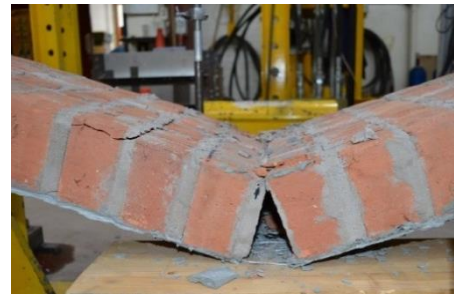
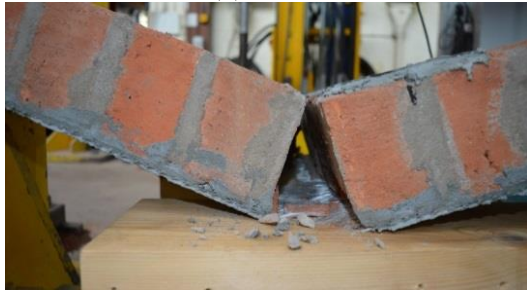
Fig. 6 Failure modes of single-wythe specimens

(a) S_C1

(b) S_C1_(Co)

(c) S_G3

(d) S_G3_(Co)

(e) S_G7

(f) S_G7_(Co)

The failure mode observed in the strengthened specimens varied, depending on the textile material used, the presence of coating or not and the number of applied layers. The observed failure modes comprised textile rupture (S_C1_(Co), S_G3, S_G3_(Co), S_G7, S_B3), slippage of the textile fibres through the mortar (S_C1), and shear failure of the masonry wall (S_G7_(Co), S_B7) as shown in Table 4. Failure modes of all single-wythe specimens are shown in Fig. 6.

Specimen S_C1 failed due to slippage of the textile through the mortar contrary to the corresponding coated specimen S_C1_(Co) where failure occurred through tensile rupture of the textile. Although slippage did not occur for the case of the specimens retrofitted with three and seven uncoated glass-fibre textile layers, yet the contribution of the fibre textile in the coated case was significantly enhanced, as manifested by the overall increase in their corresponding maximum strength (see also Fig. 4a). This beneficial impact of coating is attributed to the improved mechanical interlocking conditions obtained through the enhanced stress transfer mechanism from the fibres to the cementitious matrix; this eventually improves the contribution of roving filaments at the time of failure [see also, 22, 23].

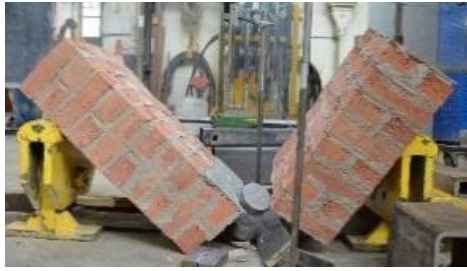
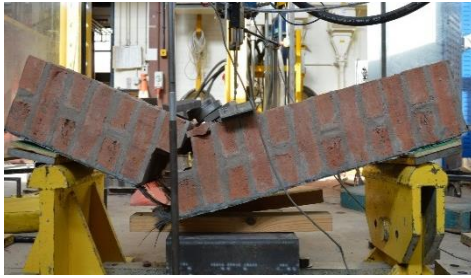
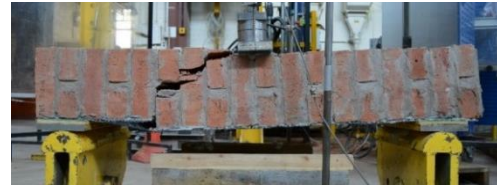
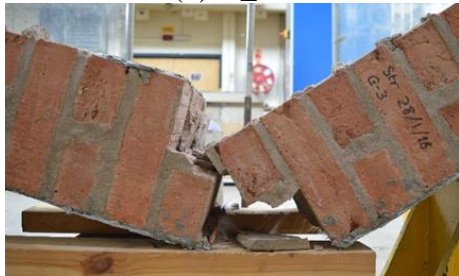
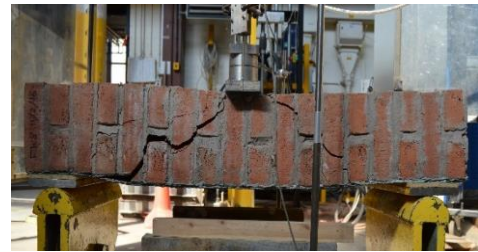
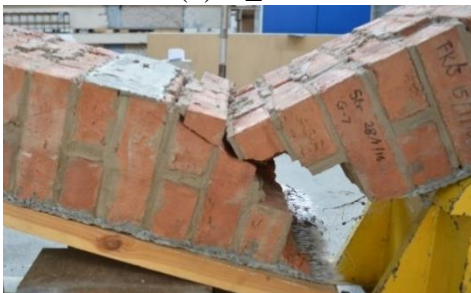
Fig. 7 Failure modes of double-wythe specimens

(a) D_CON

(b) D_C1

(c) D_C1_(Co)

(d) D_G3

(e) D_G3_(Co)

(f) D_G7

The control specimen D_CON failed in flexure in an abrupt and brittle fashion. The maximum load and corresponding displacement was 3.1 kN and 1 mm, respectively. As in the case of the single wythe specimens, strengthened double wythe specimens demonstrated a significantly improved response with respect to their maximum attained loads and corresponding deflections. As shown in Table 4, specimens D_G7, D_G7_(Co), and D_B7 demonstrated the highest increase in maximum attained load which was on average 21 times the maximum load of D_CON.

The observed failure loads were textile rupture (D_C1, D_G3), diagonal tension (D_B7), shear flexure followed by TRM debonding (D_G3_(Co), D_G7_(Co)), shear-flexure followed by textile rupture (D_G7), and shear-flexure followed by brick sliding and partial textile rupture (D_C1_(Co), D_B3). Failure modes of all single-wythe specimens are shown in Fig. 7.
